PASSAIC RIVER BASIN
DEN BROOK, MORRIS COUNTY
NEW JERSEY

OPENAKA LAKE DAM

NJ 00780

PHASE 1 INSPECTION REPORT
NATIONAL DAM SAFETY PROGRAM

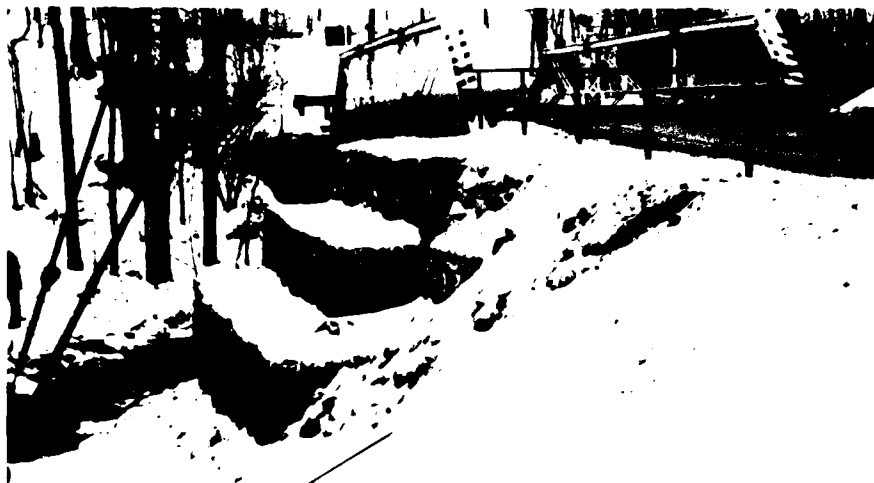
PHOTO 5
DOWNSTREAM SIDE OF DAM

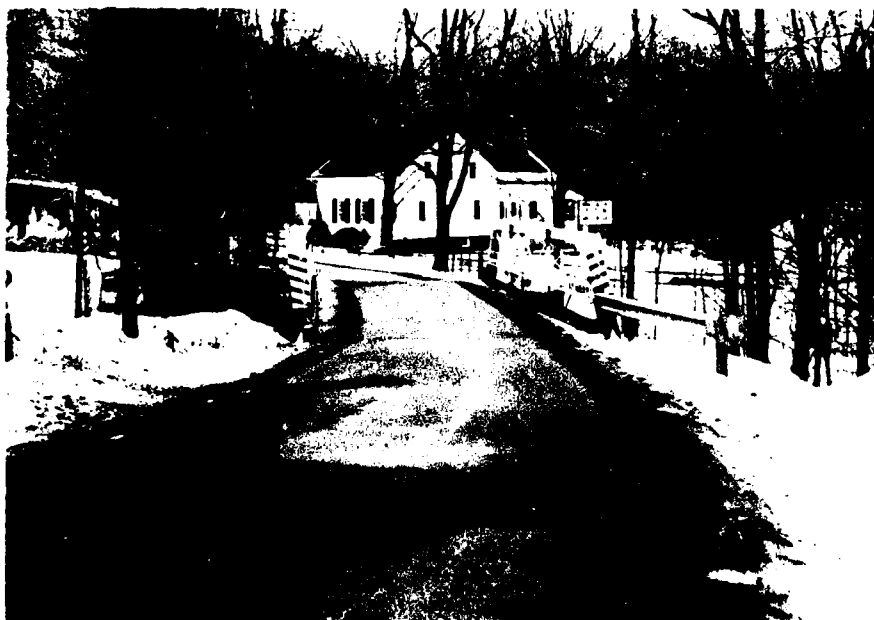
The right and left embankments were overgrown with trees and bushes on their upstream side. The trees ranged in size from 2 inches to 12 inches. The roadway pavement was patched but appeared to be in satisfactory condition. Near the right end of the stone rubble wall on the downstream side right embankment where the wall is about 3 feet high, the wall was bulging out approximately 1 foot due to sloughing of the embankment. The wall however, was not undermined at its base. The remainder of the wall which is composed of grouted stone appeared to be in generally satisfactory condition. An 8-inch deep depression in the soil approximately 4 feet to the right of the spillway

PHOTO 6
CREST OF DAM

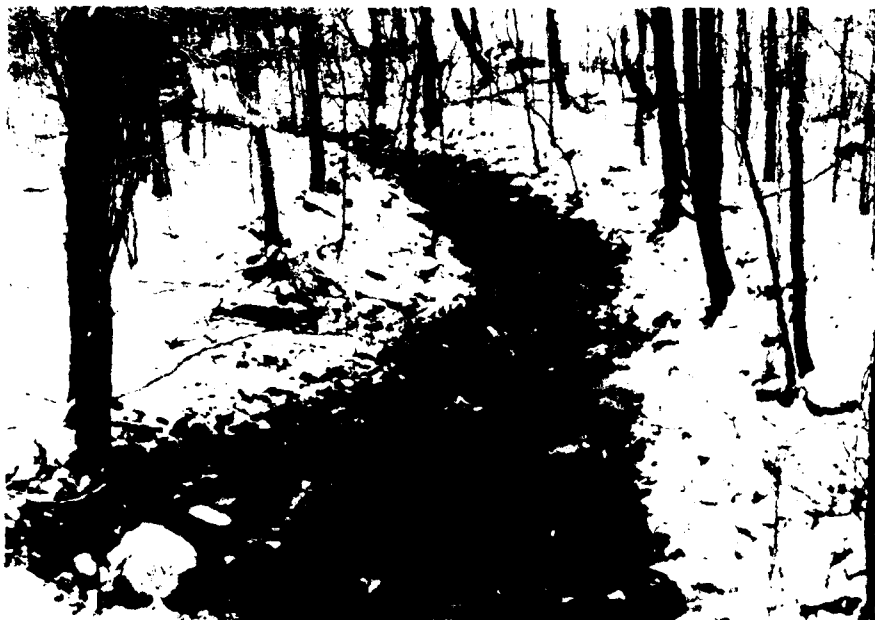
PHOTO 10

Orange stains were noted on several of the rocks in the bed of the downstream channel. These stains could be rust stains from the low level outlet pipe which was severely rusted. Orange stains were also noted on the rocks and in the bed of the downstream channel on its left bank approximately 20 feet downstream from the downstream toe of the dam. These orange deposits did not appear to be rust stains, but could have been related to seepage.

DOWNSTREAM CHANNEL
